# **Chemical Sciences Division**

# Fiscal Year 2015 Environmental Health and Safety Self-Assessment Report

# **Chemical Sciences Electrical Safety**

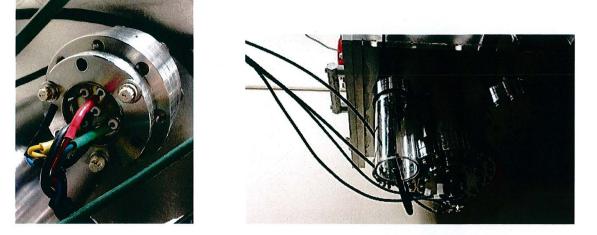
The high voltage pass-through shown in figure 3 is used to pass electrical signal into and out of vacuum chambers. The conductors are reasonably well protected by the colored heat shrink, but as an extra layer of safety these conductors were isolated with a cover.

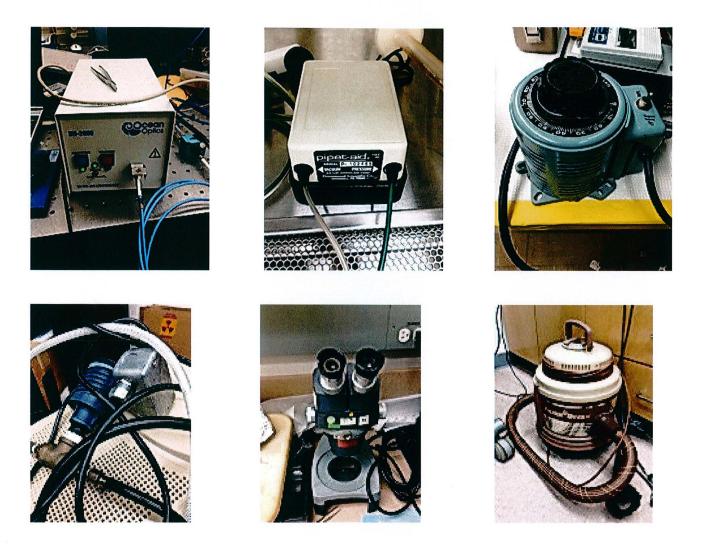
Figure 8: Electrical items deficient in Electrical Equipment Safety Plan.

The representative pictures presented here are just a sampling of the items that were identified and addressed. In all, 52 pieces of equipment needed surveyed into the EESP, and all surveys were completed. In addition, 3 items were red tagged and taken out of service.

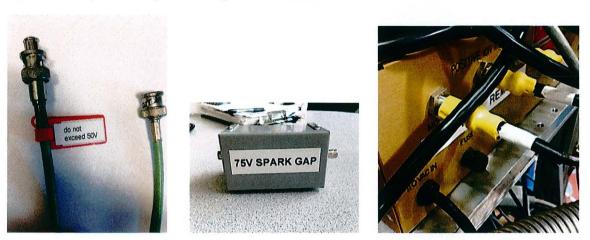
Figure 11: Examples of safeguards for disparate connectors.

Another way to keep control of these connectors is to heat shrink them permanently onto the instrument (figure 11). This can be done for example with an older instrument containing an MHV output. A MHV to SHV cable or adaptor can be affixed with heat shrink to insure that it stays in place and does not get used improperly or in another location.

Spark-gap boxes can be used to protect from over voltage (figure 11). The MHV connector is typically rated for 5000 volts DC and 3 amperes, but the BNC is not recomended over 500 V. When a MHV to BNC connection is needed, a spark gap box can be designed with the MHV input and the BNC output. The system can then be installed with MHV – MHV and BNC – BNC cables, but the spark gap will protect the BNC cable from overvoltage.

Figure 11 also shows a cable that has been labled in a way to protect it from an over volage hazard.

Cables can also be labeled for specific use or with warning information about the cables. In the case pictured in Figure 11, the cable is labeled to prevent an over voltage of the lower rated component.
