11/30/2011

LAWRENCE
BERKELEY
NATIONAL
LABORATORY

FACILITIES DIVISION SELF ASSESSMENT
PENETRATION PERMIT TECHNICAL ASSURANCE
PROGRAM

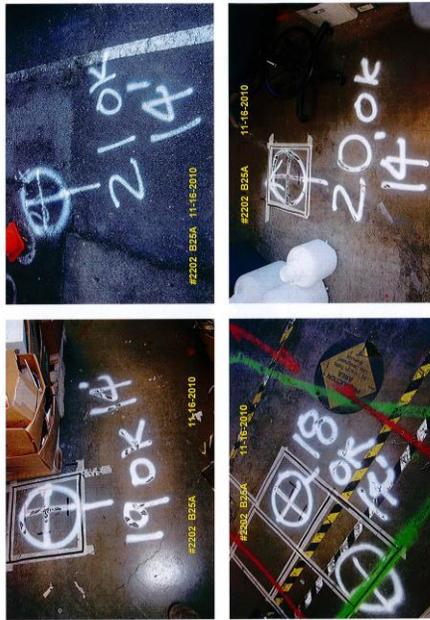
1. The photos attached to the Penetration Permits are very detailed and precise.
