Chemical Sciences Division

Fiscal Year 2015

Self-Assessment Report

Chemical Sciences Electrical Safety

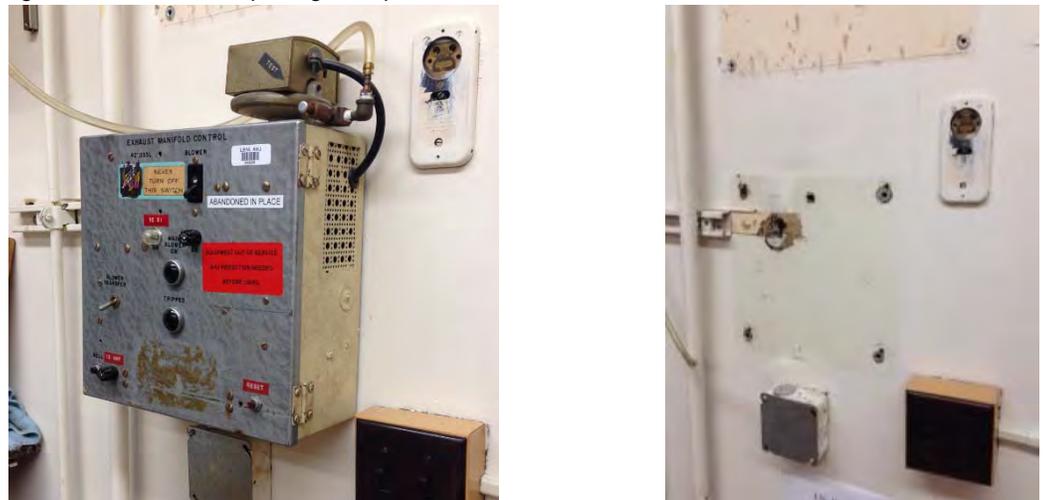
Figure 2: Control Box Opening to Expose Live Wires.

The control box pictured in figure 2 was abandoned in place many years ago and was thought to be de-energized. This item is placed next to the laboratory door in room 70A-1159A. When conditions were just right as the laboratory door shut, the door to the control box would pop open and expose electrical wiring. Testing of the circuit by Facilities electricians revealed that the conductors were still live. Subsequently the circuit was de-energized and the control box was removed.

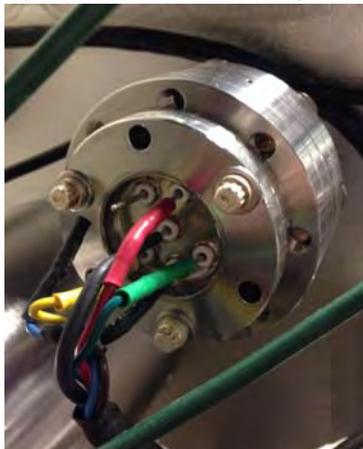
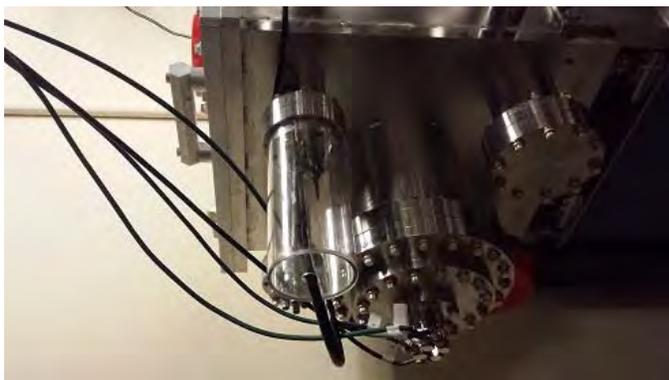
Figure 3: Cover added to High Voltage Pass-through.

The high voltage pass-through shown in figure 3 is used to pass electrical signal into and out of vacuum chambers. The conductors are reasonably well protected by the colored heat shrink, but as an extra layer of safety these conductors were isolated with a cover.

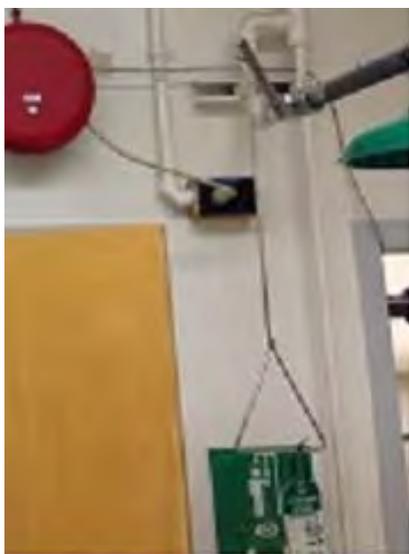
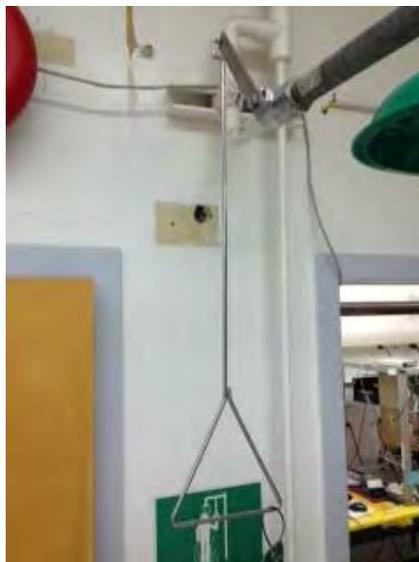
Figure 4: Electrical Plug Removed.

Figure 4 shows an electrical plug on the wall right behind a safety shower. This plug was removed from this location and relocated to a dry location.

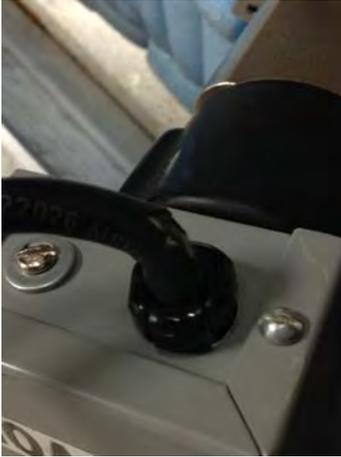
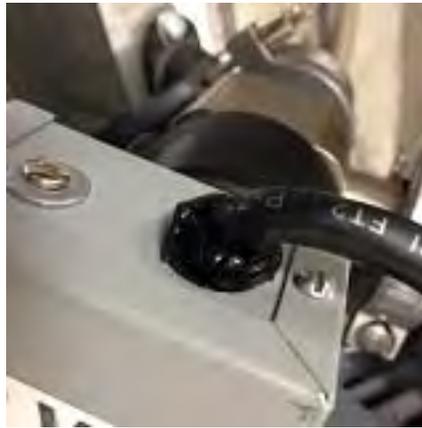
Figure 5: Damaged Pump Cord Replaced.

The wire insulation on the vacuum pump shown in Figure 5 was damaged and needing repair. The pump was taken out of service until the cord was repaired.

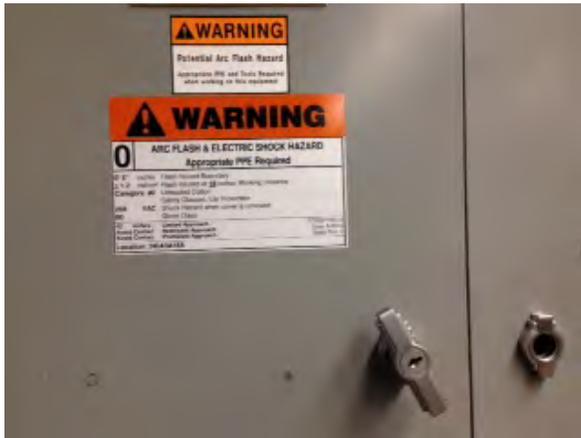
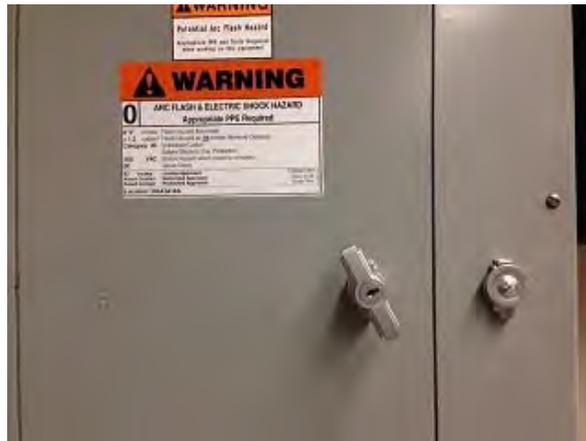
Figure 6: Hole in Arc Flash Barrier.

Figure 6 shows an electrical panel with a hole in the front cover. This electrical panel has an arc flash hazard as can be seen by the label in the photo, and the cover is a barrier to the arc flash. The hole would have allowed an arc flash to enter into the room, and the workers in this space would have been placed at risk. The hole has now been plugged.

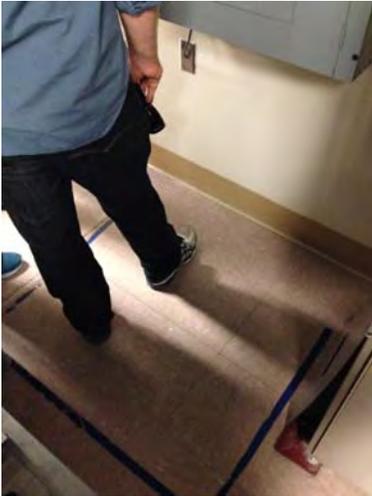
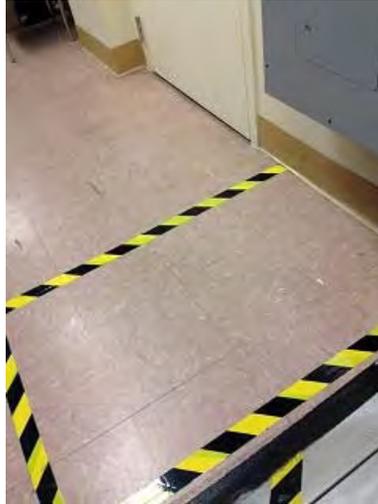
Figure 7: Demarcation tape around electrical panels.

The demarcation tape on the floor in several areas was missing, damaged, or as shown in Figure 7 where the wrong tape was used. All areas identified were addressed.

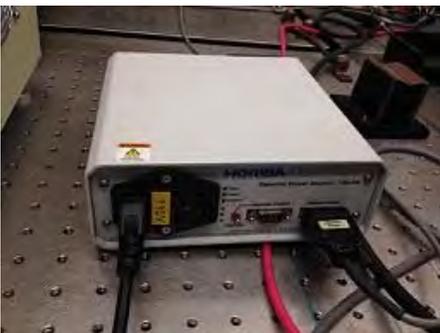
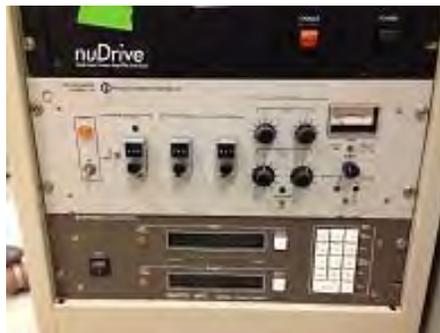
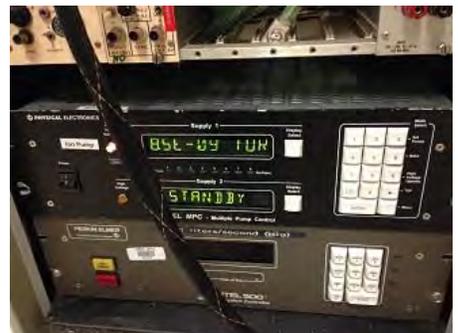
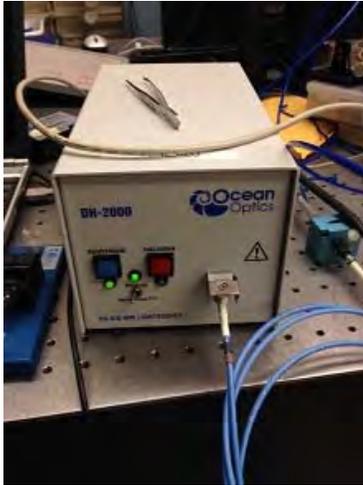
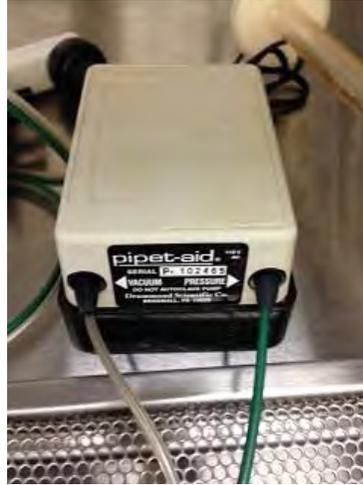
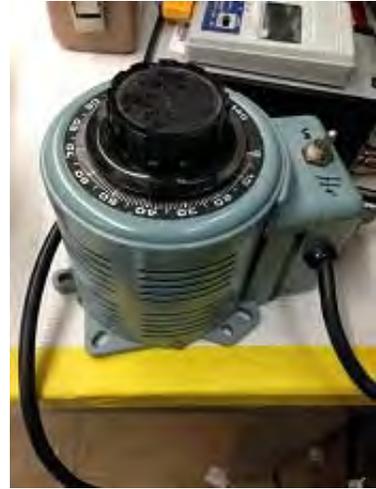
Figure 8: Electrical items deficient in Electrical Equipment Safety Plan.

The representative pictures presented here are just a sampling of the items that were identified and addressed. In all, 52 pieces of equipment needed surveyed into the EESP, and all surveys were completed. In addition, 3 items were red tagged and taken out of service.

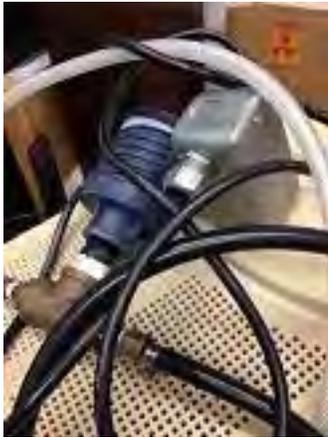
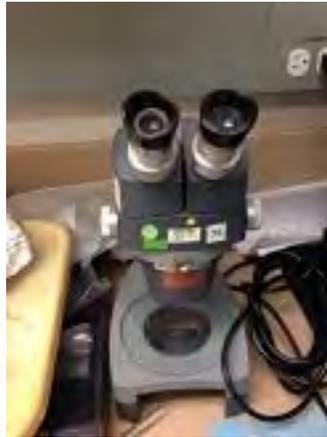
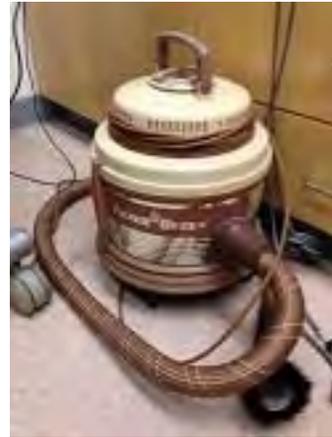
All electrical equipment in use at Berkeley Lab must be approved through the Electrical Equipment Safety Program (EESP). Poorly engineered electrical equipment can pose serious electrocution and fire hazards and it is the goal of the EESP to identify this unsafe equipment. Electrical equipment that is not NRTL-Listed must be surveyed into the program, inspected by a qualified electrical inspector, and if needed, repaired by a qualified electrical worker. Figure 8 shows representative item that were identified during this self assessment that were not properly processed in the EESP.

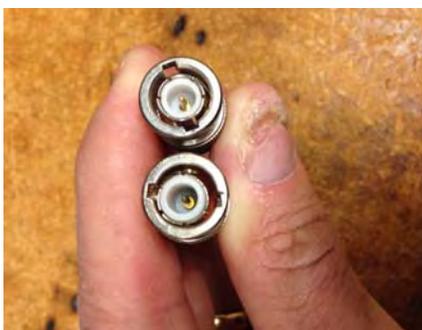
Figure 9: BNC and MHV connectors.

The MHV (miniature high voltage) connector looks almost identical to a typical BNC connector (figure 9), but is not designed to mate with BNC jacks. MHV connectors can be recognized by the slightly protruding insulation on the male plug and the slightly different

insulation length in the female jack. Despite these design differences, MHV and BNC plugs and jacks can be made to mate with a little force. This can create a safety hazard, if a user accidentally mates a low voltage cable to a high voltage jack.

Moreover, because of the possibility of high voltage on the exposed central pin when not plugged in and because the ground connection is broken before the power connection when de-mating. It is recommended that researchers use SHV connectors. SHV connectors are designed to prevent these hazards, and cannot be mated to BNC connectors.

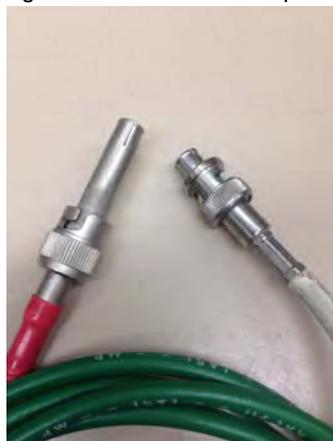
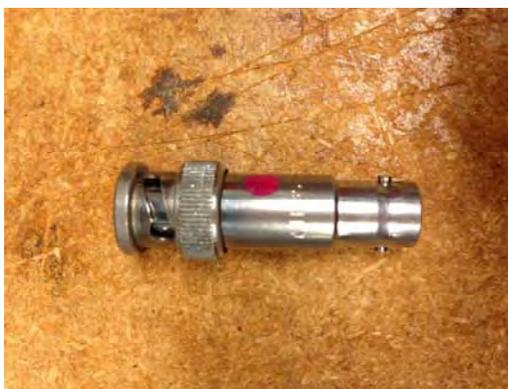
Figure 10 gives an example of the type of cables and adaptors that were discovered in chemical sciences spaces, but a complete list can be found in Appendix 3.

Figure 10: Cables and adaptors discovered in chemical sciences spaces.

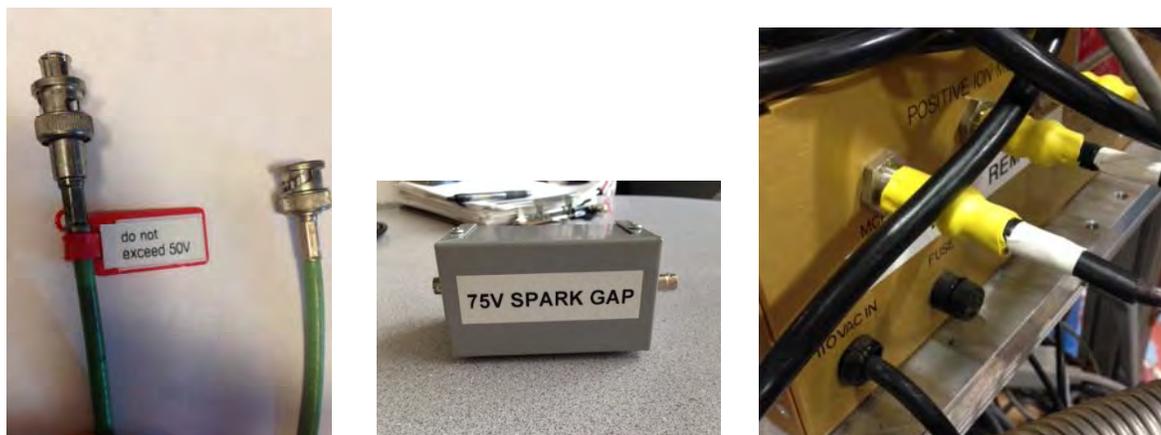
Another way to keep control of these connectors is to heat shrink them permanently onto the instrument (figure 11). This can be done for example with an older instrument containing an MHV output. A MHV to SHV cable or adaptor can be affixed with heat shrink to insure that it stays in place and does not get used improperly or in another location.

Spark-gap boxes can be used to protect from over voltage (figure 11). The MHV connector is typically rated for 5000 volts DC and 3 amperes, but the BNC is not recommended over 500 V. When a MHV to BNC connection is needed, a spark gap box can be designed with the MHV input and the BNC output. The system can then be installed with MHV – MHV and BNC – BNC cables, but the spark gap will protect the BNC cable from overvoltage.

Figure 11 also shows a cable that has been labeled in a way to protect it from an over voltage hazard.

Figure 11: Examples of safeguards for disparate connectors.

Cables can also be labeled for specific use or with warning information about the cables. In the case pictured in Figure 11, the cable is labeled to prevent an over voltage of the lower rated component.

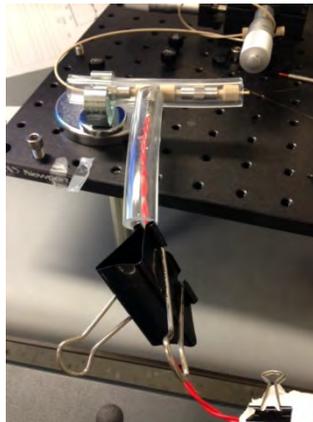
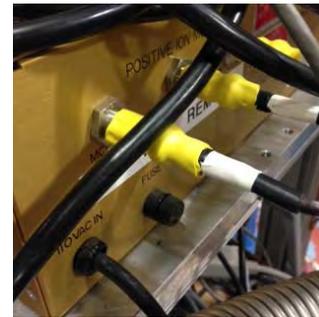
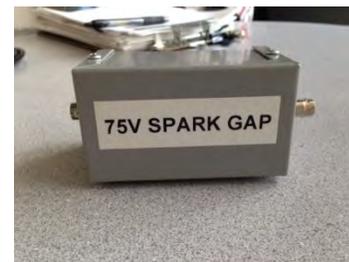
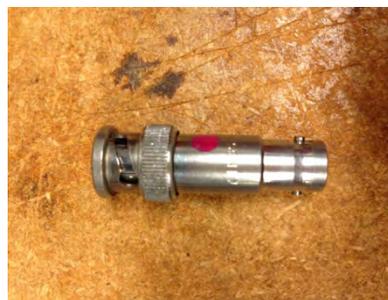
70A, David Shuh;

- 10 MHV to SHV adapters.
